Standards for Non-Revenue Water Management in Kenya

Case Studies

Case Study MEWASS

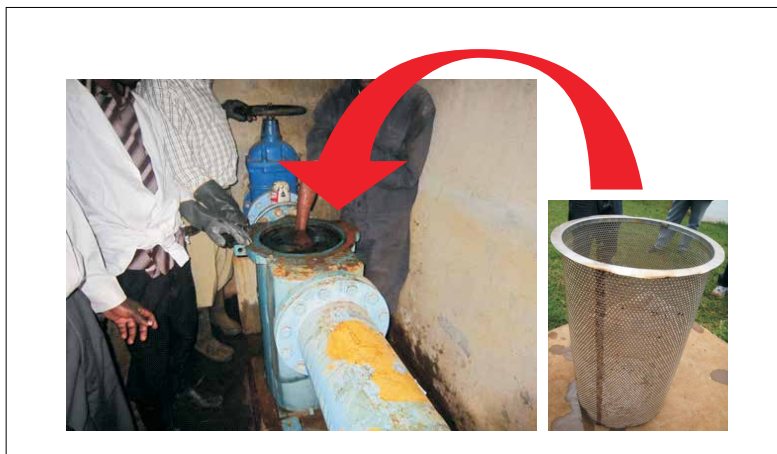
Photo 4.1 installation of Strainer

- 1) **Strainer:** This will trap suspended materials in the water, which causes problems in the water meters.

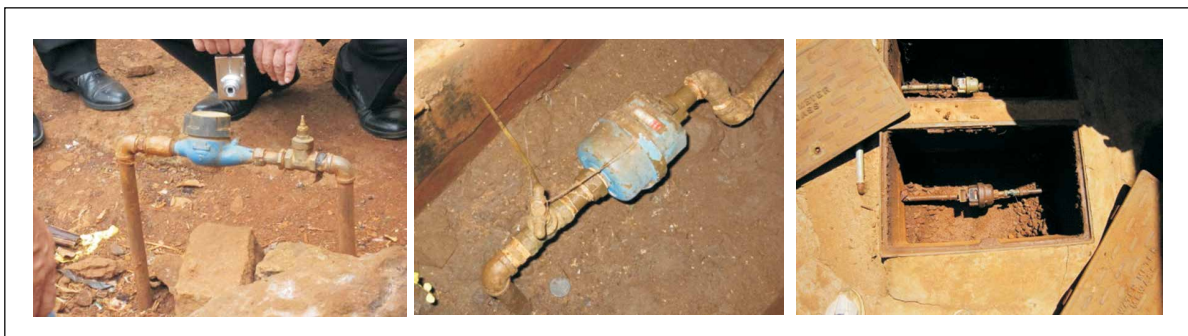
Photo 4.2, 4.3, 4.4: Example of Water meter

- 4) **Customer Water Meter:** Customer Meters must be installed 100%. It is important that the ledgers for the Master Meter for the distributed area and the ledger for the Customer Meters must correspond with each other, so that System Input Volume (Supplied Volume) and the Consumption Volume can be compared.

- The meter is installed preferably 1m inside the plot at a location away from waste water and obstructions for easy access by meter readers
- The meters are installed at a position lower than the house water tap to avoid intrusion of air into water meter, which will influence accuracy of water meter.
- The meter is installed horizontally (for rotary meters) and horizontally or vertically (for piston meters) in order to keep it in good quality and enhance its durability. A household connection including the meter is installed at the following places:
 - At every individual household dwelling
 - At community points or water kiosks

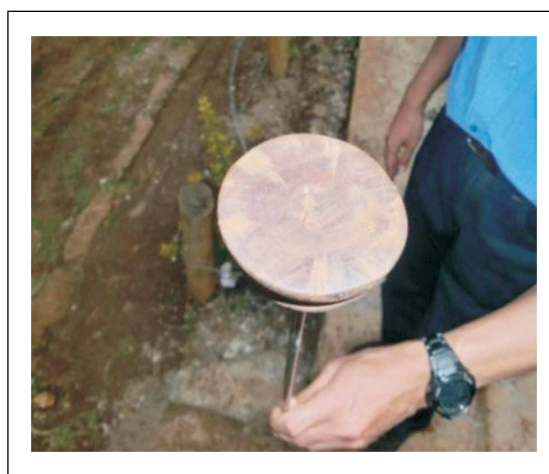
Photo 5.1 Listening Stick

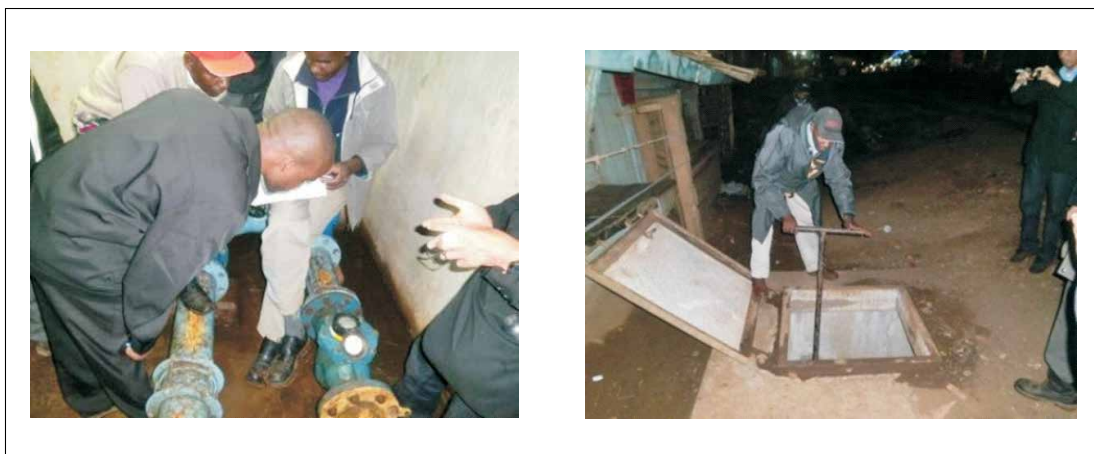
Photo 5.2 Step test measurement (Left: measuring flow volume, Right: Closing gate valve)

The activity started at 24:00 and measurements were taken until 3:30 a.m. These measurements provide details of abnormal flow of the 17 sub zones.

Table 5.5 indicates the results of the measurements.

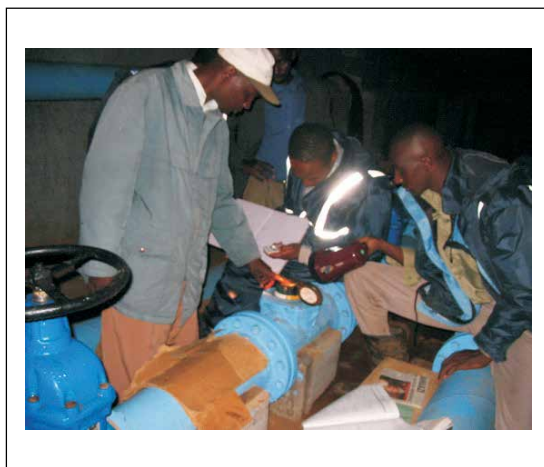
Photo 5.5 Night Flow measurement

In order to calculate the NRW components, it is important to emphasize that measured data is the basis of calculation. During the years 2004 and 2005, MEWASS conducted hourly readings of water flow of each zone to produce the water demand characteristic curve. This characteristic curve is used the management of water works, but the Night Flow Measurement is an effective tool to estimate the NRW Physical Loss. It is recommended that all WSP prepare the water demand characteristic curve, but it is important for each WSP to understand that Night Flow Measurement is not equivalent to Physical Loss.

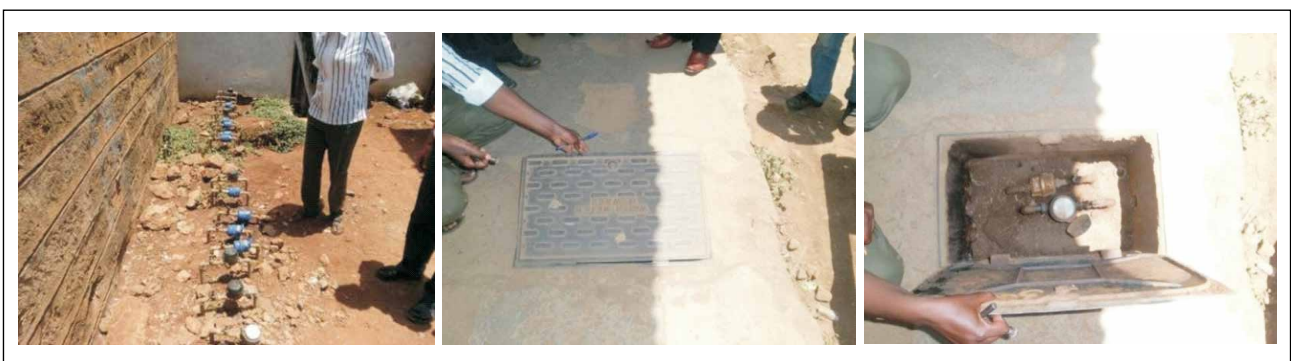
Photo 5.6 Placement of the meter

As much as possible, meters are installed along the highway or major roads as shown in Photo 5.6. Installing meters near the parameters of customer land and the major road should be encouraged.

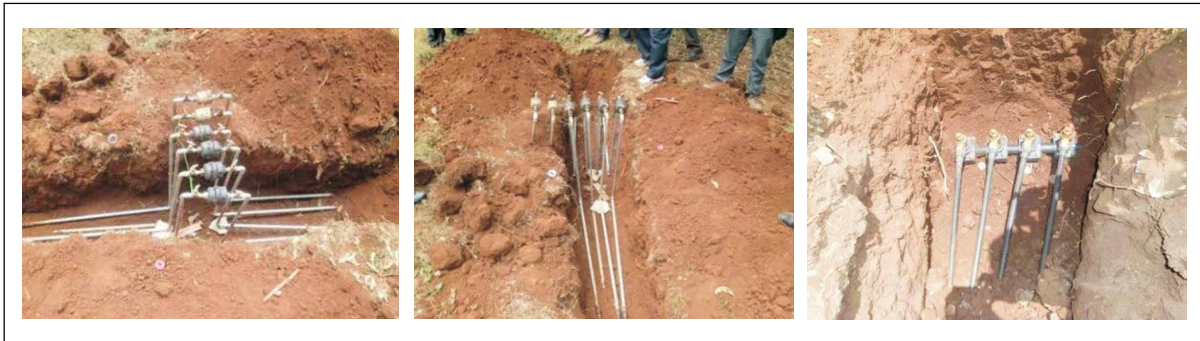
Photo 5.7 Placement of Service Pipe

Photo 5.7 shows a recent meter installation construction. This meter is being placed about 5 meters from the boundary. Unless there are problems, it is recommended that the meter be placed about 1-2 meters from the boundary. By placing these meters as recommended, management of leakage and management of sub zones will become much easier.

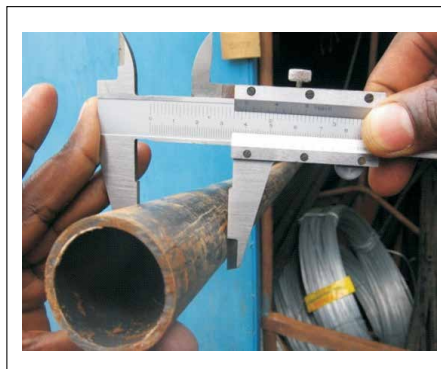
Photo 5.9: Measuring pipe diameter

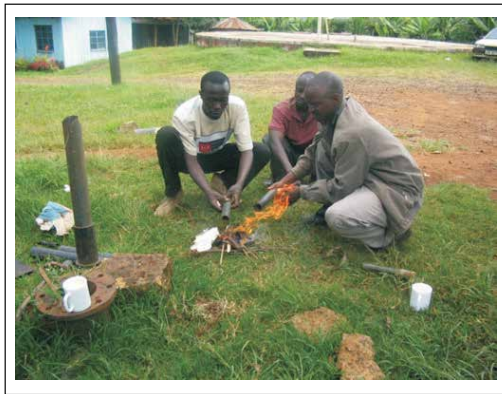
Photo 5.12: Fire Coupling

As shown in Photo 5.12 and Photo 5.13, when different thicknesses of pipes or internal pipe diameters do not match, fire couplings, rubber and / or plastic paper bends are still being used.

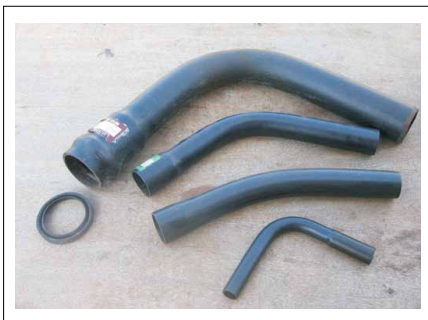
Photo 5.14: Various Angles & Diameter Bends

Photo 5.14, 5.15 and 5.16 show pipe fitting parts that were developed by MEWASS

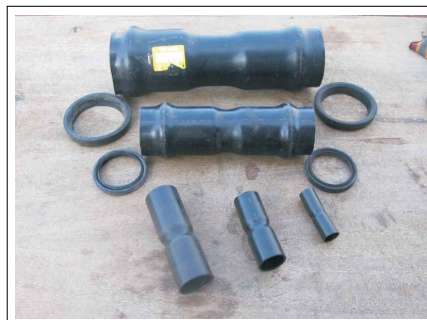
Photo 5.15: Socketed & Plain Repair Couplings

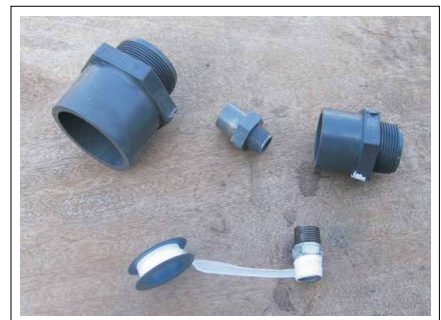
Photo 5.16: Tread seal PTF used with uPVC & GI Threaded Fitting

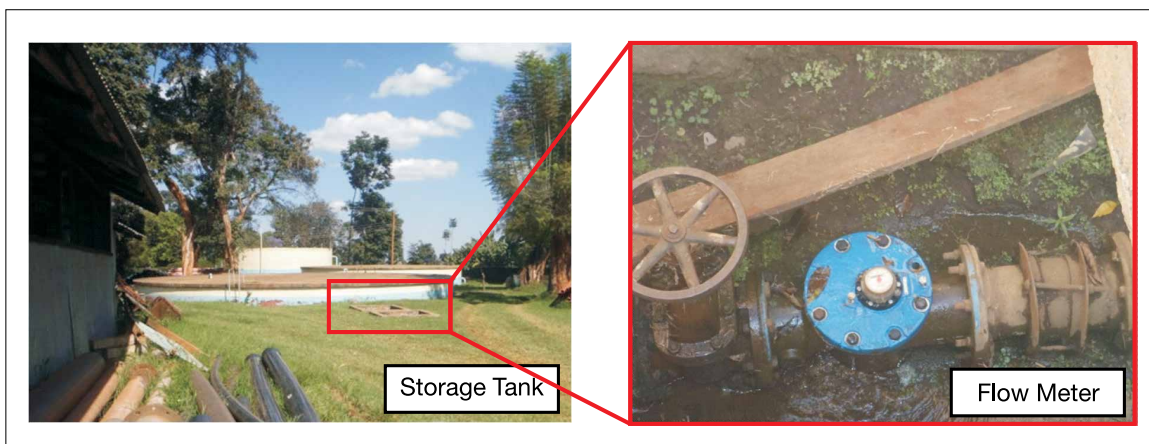
Photo 1.1: Installation of Flow Meter at Outlet of Storage Tanks

The installed flow meters must be tested for accuracy. If any of the flow meters show inaccuracy, they must be replaced them as early as possible.

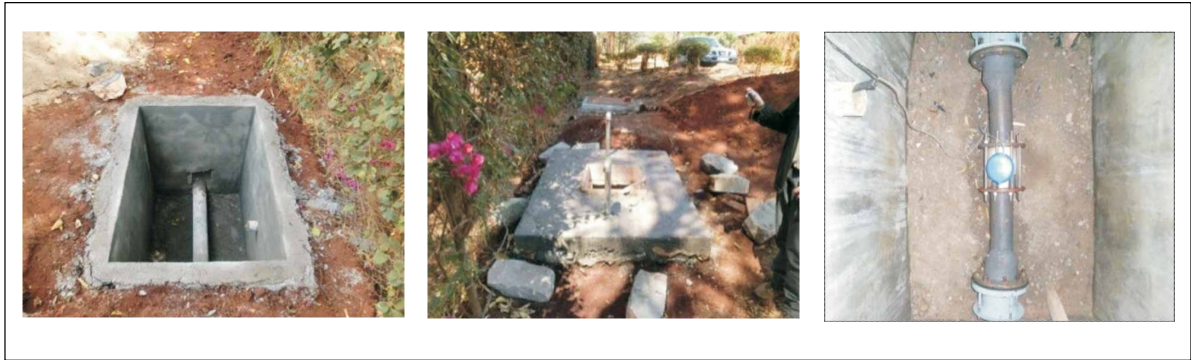
Photo 2.1 Construction and install of New Master meter and chamber

Master meter chamber is constructed to install flow meters that measure water flow into all areas of pilot project. It is necessary to secure joint materials for the installation of measure water flow using ultrasonic flow meter.

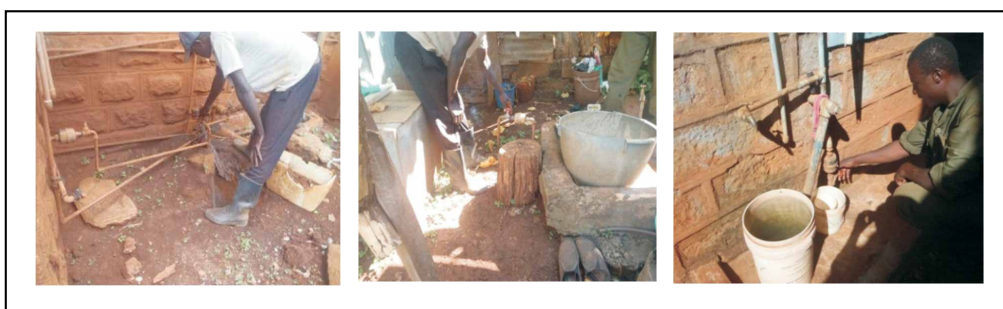
Photo 2.3: Survey of Customer Water Meter

Inspection of customer meter is conducted through sight survey include register, non-functional meter, non-visible meter, illegal connection, leakage etc.

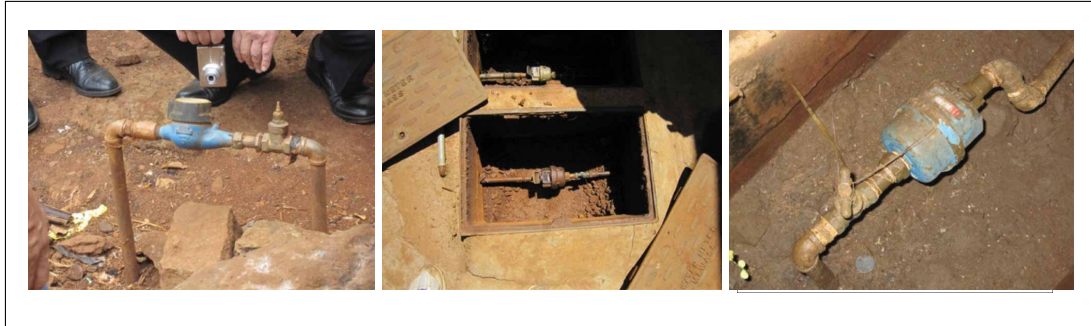
Photo 2.4: Customer Water Meters in Embu

Customer Meters must be installed 100%. It is important that the ledgers for the Master Meter for the distributed area and the ledger for the Customer Meters must correspond with each other, so that Distributed Water Volume and the Consumption Volume can be compared.

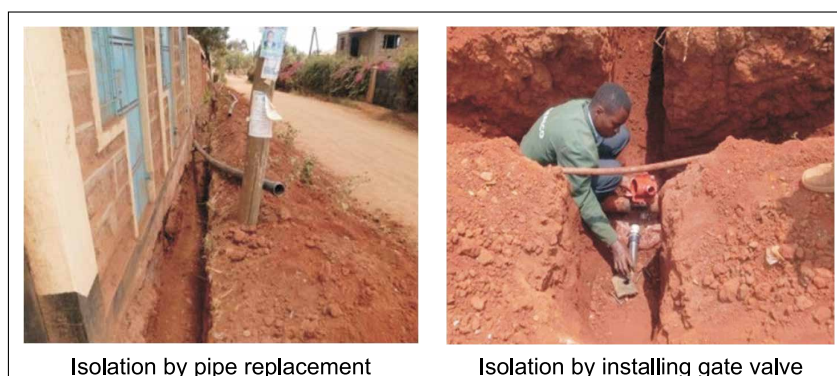
Isolation by pipe replacement

To knowing accuracy distribution and consumption volume in sub-block, zoning work is important. Considerable works for zoning one sub-section from another sub-block are installation gate valve and replace of pipe.

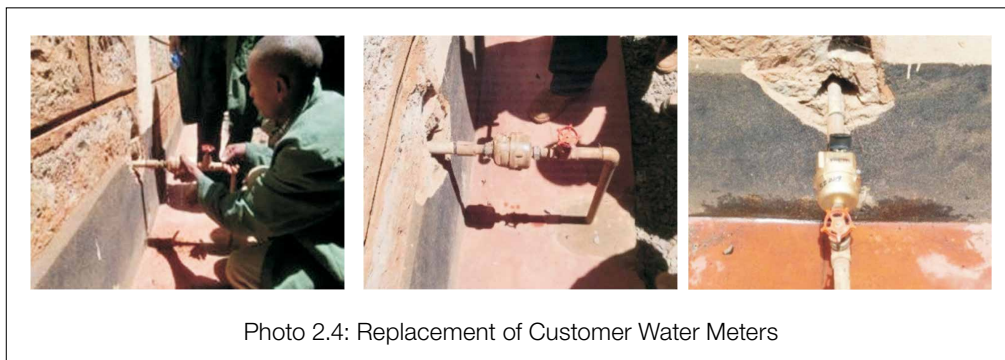
Photo 2.4: Replacement of Customer Water Meters

EWASCO had replacement water meter such as old or broken. The old and broken meter will take inaccuracy data of consumption volume of each residence.

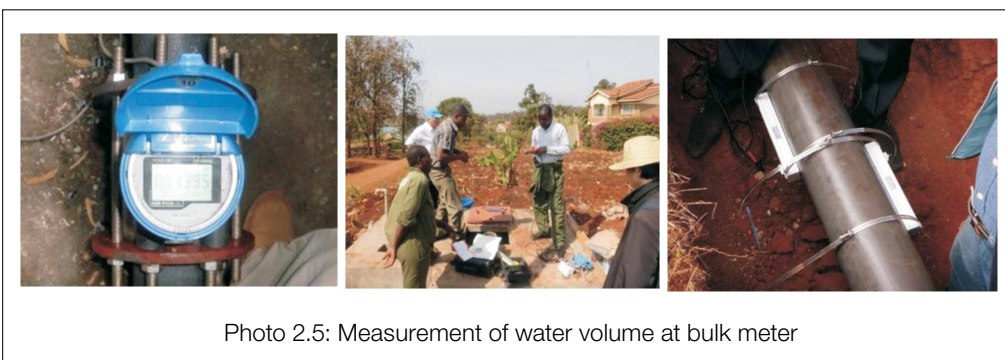
Photo 2.5: Measurement of water volume at bulk meter

To Reducing Non-revenue water, we need to know accuracy water volume of distribution. EWASCO built bulk meter and valve chamber at the entrance of sub-block. After build chamber and bulk meter installed, they can read each meter in chamber and they can do monitoring volume of water that flow into sub-block individually with bulk meter

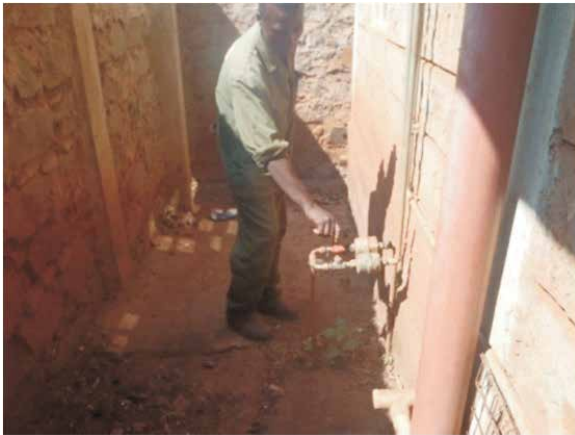
Photo 2.6: Close all peripheral valves of the block and all the customer valves completely

Set the measuring block with 3 to 5 kilometers of distribution pipes, close all peripheral valves of the block completely, followed by shutting all the customer valves completely, then, measure the flow rate into the block at the one point. The work is usually carried out during midnight to avoid inconvenience of customers. This method can measure the existing leakage volume in the block rather precisely but it may include losses by water theft, and takes a lot of time and needs much manpower. For these reasons, this method is unpopular nowadays.

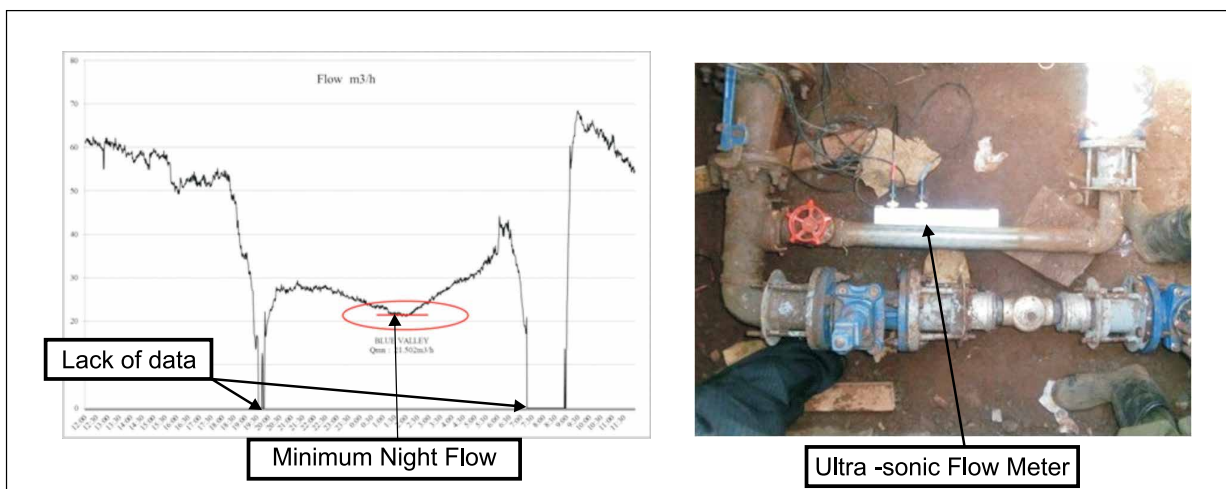
Figure 2.2 Data of daily transition of volume to sub-section

EWASCO measured minimum night flow (MNF) volume by using ultra-sonic flow meter. Ultra-sonic flow meter is portable, so it can collect data on purpose. MNF is one of the indicators of leakage volume in sub-section called DMA (District)

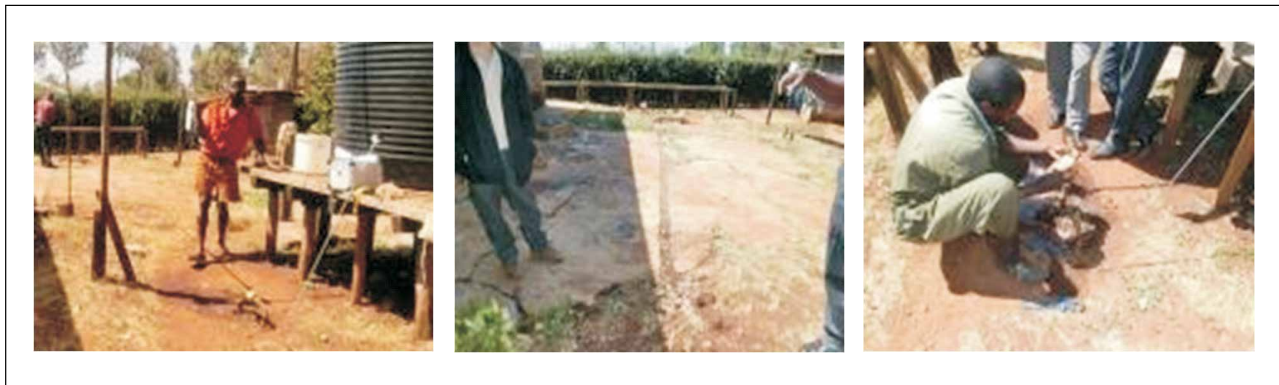
Photo 2.9: Detection of Illegal Connections

EWASCO carried out patrol work for detecting of illegal connection and defective meter by sounding and door-to-door checkout. After finding water-theft losses and metering error losses, they stopped valve and correct illegal connections and replacement defective customer meters.

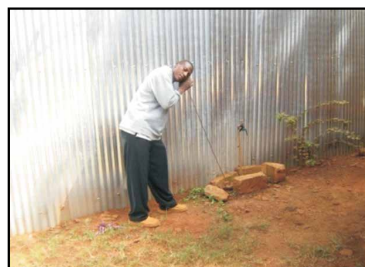
Photo 2.11:
Leak detection using
Listening Stick

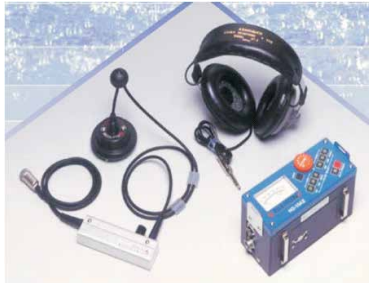
Photo 2.13:
Electronic leak detector

EWASCO also tried definition of leakage location by using Electronic Leak Detector. An electronic leak detector consists of a main unit, a pickup, a head phone and a remote control unit.

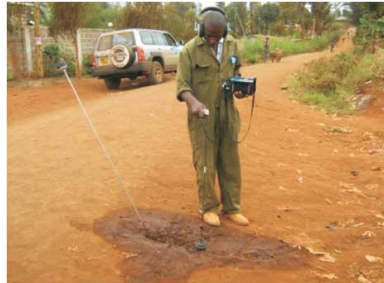
Photo 2.14:
Leak detection using
Electronic leak detector

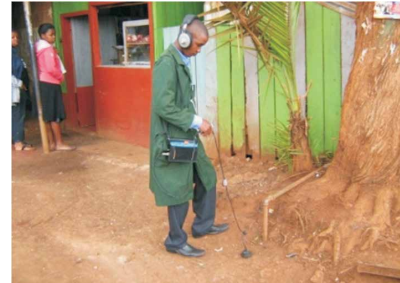
Photo 2.15:
Leak detection using
Electronic leak detector

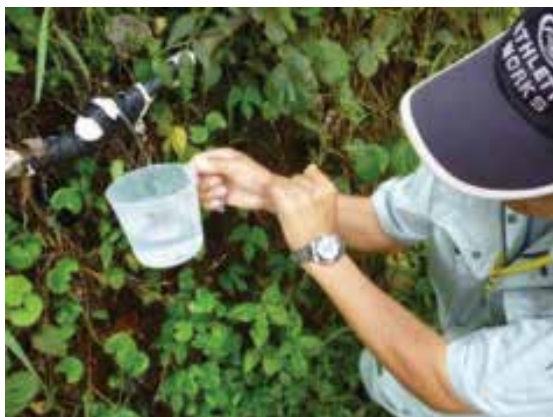
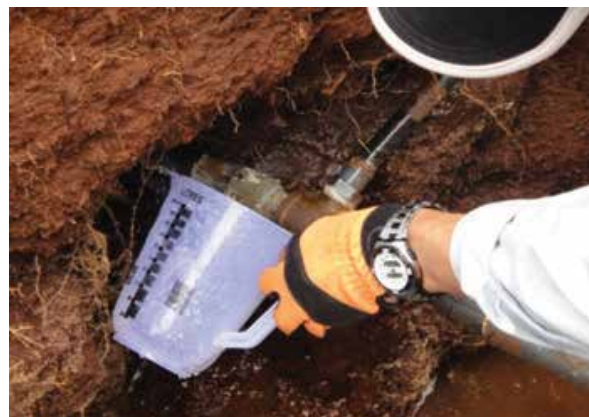
Photo 2.16: Direct measure of Leakage Volume

It is important to measure volume of leakage water at detected point as showed by Photo 2.16.

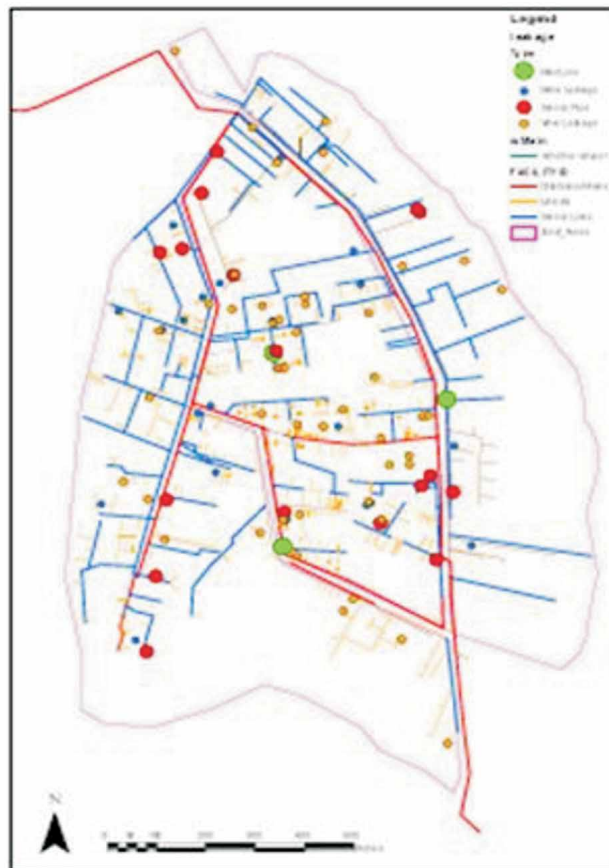
Figure 2.3 Map of Leakage by survey in Pilot project

EWASCO compiled Leakage map to make easy their pipeline management after leakage survey. Figure 2.3 shows map of leakage in pilot project area. This map helps them to make strategies to improve their facilities by replace pipe or controlling pressure.

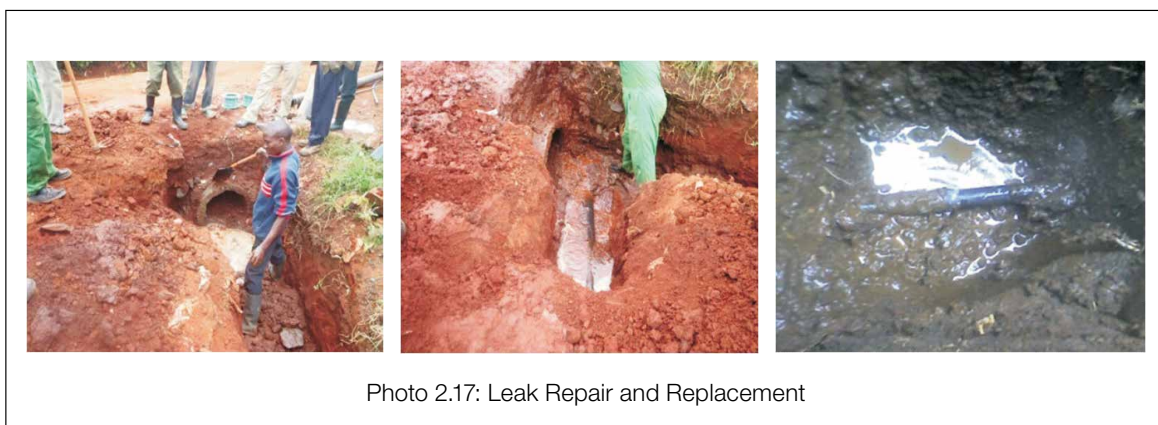
Photo 2.17: Leak Repair and Replacement

After detected location of Leakage, EWASCO repaired leakage by replacing broken pipe and change old and invalid customer meters.

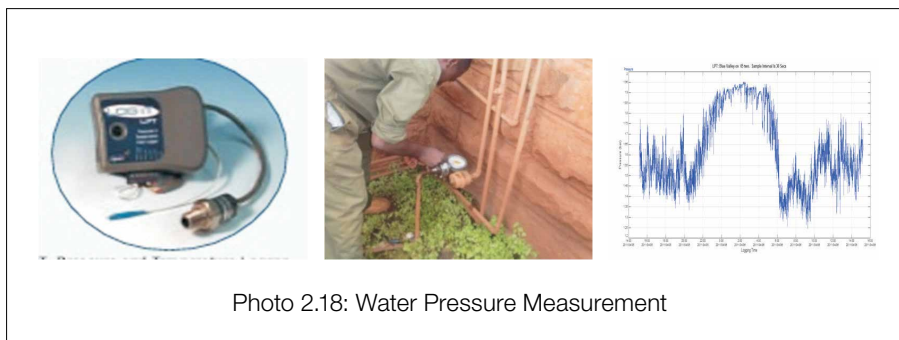
Photo 2.18: Water Pressure Measurement

EWASCO started their management of water pressure from measuring water in the pilot project area. They measured pressure by handy pressure gage and made a graph shown as Photo 2.18.

Water pressure can be measured daily, periodically or randomly.

Daily measurement should measure daily water pressure at the focal point in the distribution main storage tank and pumping station. This will indicate whether the water pressure in the distribution area is being maintained at the correct range.

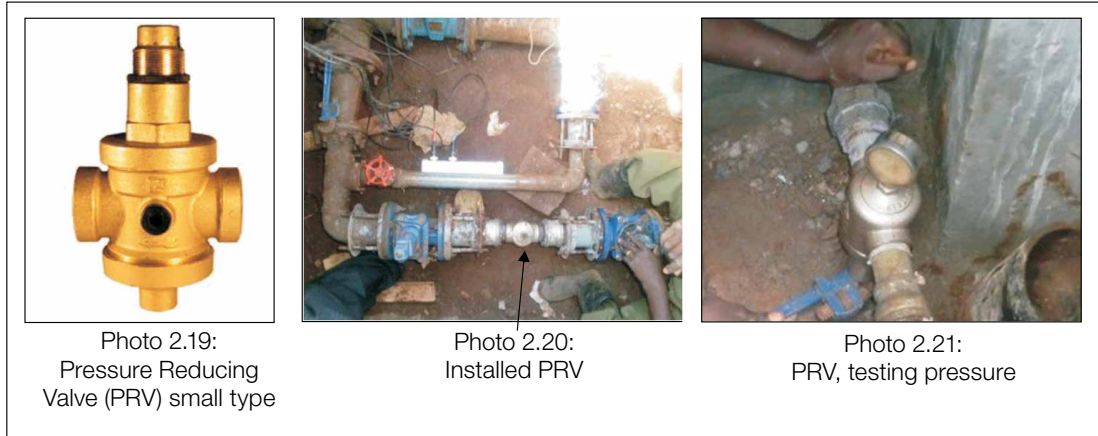
Photo 2.19:
Pressure Reducing
Valve (PRV) small type

After understanding status of water pressure, EWASCO planed installing of Pressure Reducing Valve (PRV). They start to control pressure to 0.10 MPA by small PRV and measured pressure and water volume continuously; they tried to adjust appropriate pressure for each sub-zone of pilot project area. Small PRV has advantage cheap and affordable and easy to use small diameter pipes.

Photo 2.20:
Installed PRV

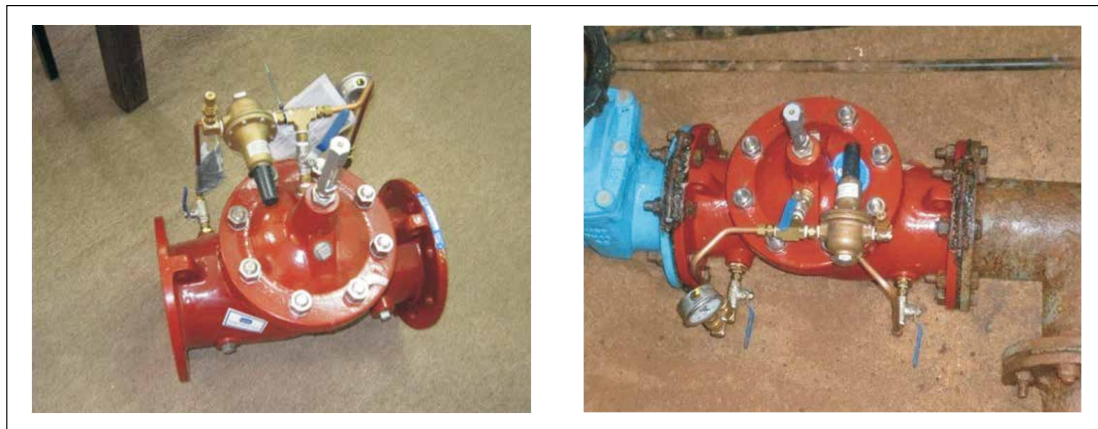
Photo 2.22: Installation of Auto PRV (large type)

After finding the suitable pressure is 0.15MPa to the sub-zone, EWASCO installed 150mm large Auto PRV that can adjust pressure automatically. Large PRV has advantage to keep regular pressure during day and night (Small type PRV could not control high pressure at the night).

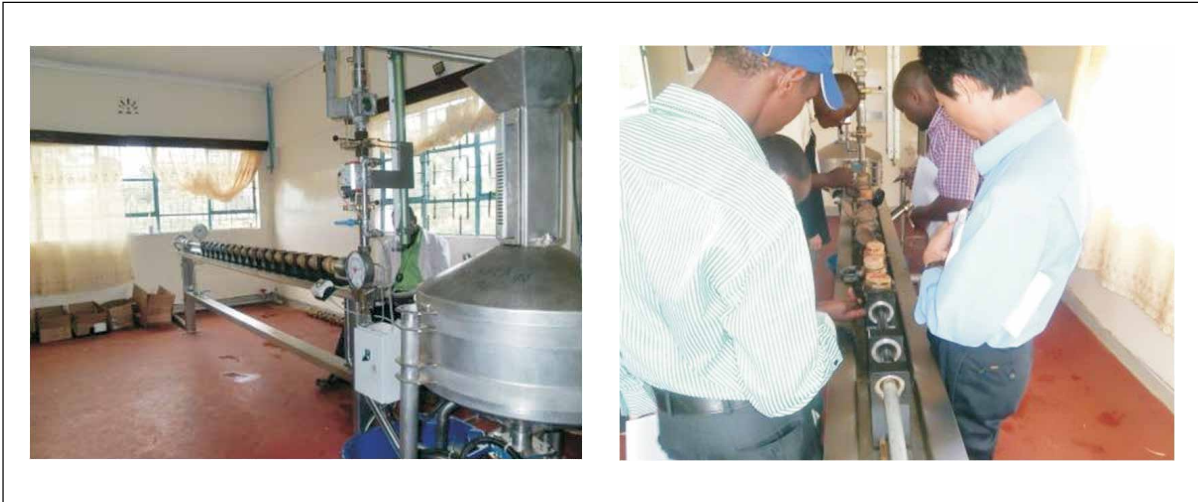
Photo 2.23: Meter Test

To create domestic water meter management plan, EWASCO tested old and invalid water meter by using test equipment of NYEWASCO(NYERI). Photo 2.23 shows the test equipment. Meter was removed from pilot area. There was chosen by high count of volume or seem to be broken old.

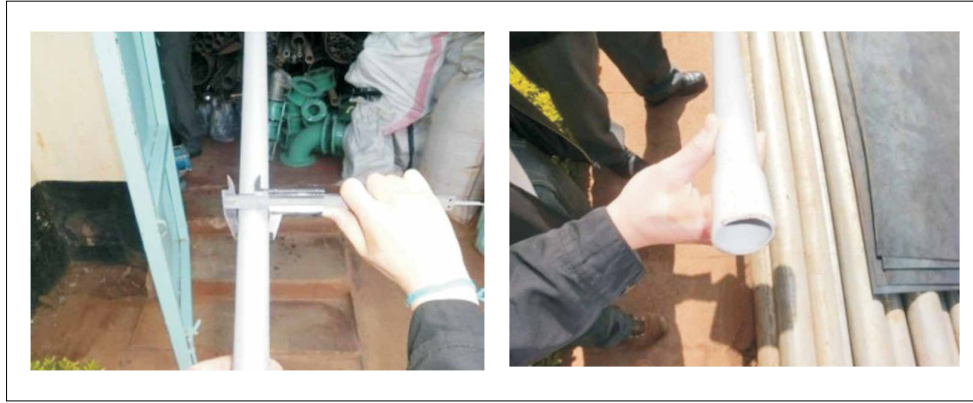
Photo 2.24: Measuring pipe diameter

The Kenya Standard of pipes is not yet regularized. Under such circumstances, EWASCO is utilizing various flexible joints for pipes such as inches or meters. Photo 2.24 shows importance of measuring size before installing. Photo 2.25 is a sample of socket which connecting pipes.

Photo 2.25: Socket of pipe connecting

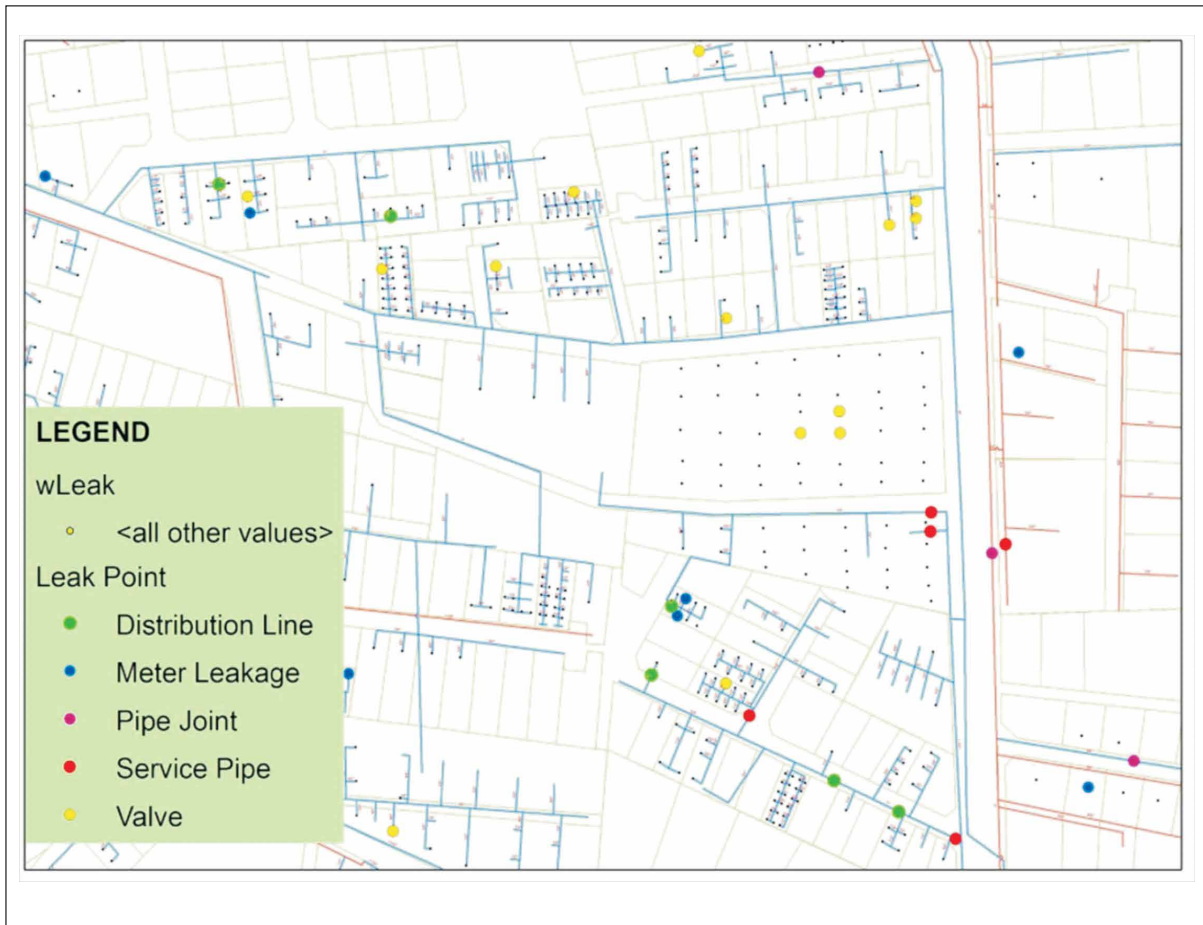
Figure 3.5 Leak survey map on GIS (EWASCO)

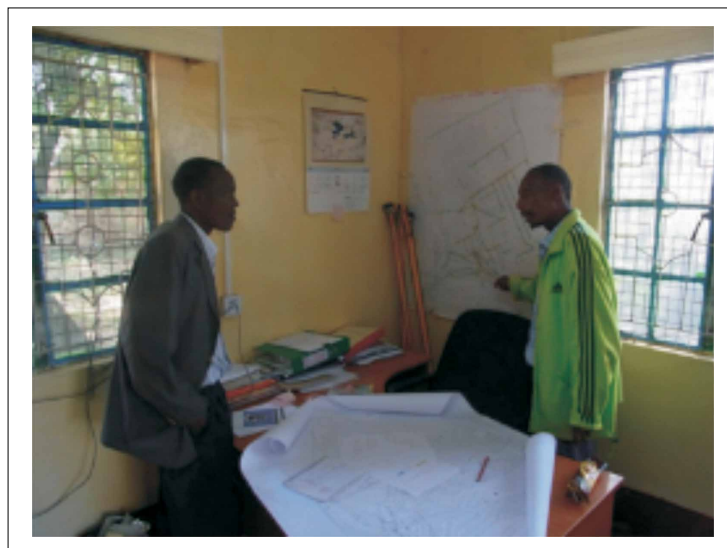
Photo 2.1 Development of Distribution Map

The procedure for the preparation of distribution pipe map was as follows. As shown in Photo 2.1, a meeting was first held to prepare a survey plan. The survey confirmed the location of pipes and types of pipes used and the location of gate valve was also confirmed.

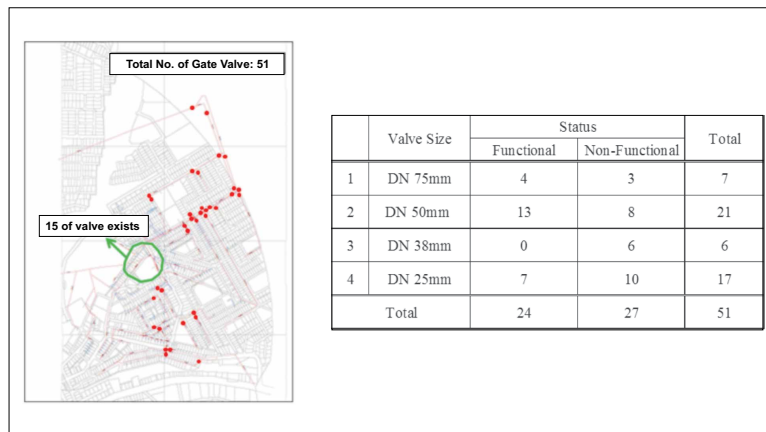
Figure 2.4 Location of Existing Gate Valve

Before implementing any Pilot Project activities, it is necessary to confirm the locations of installed valves that will allow the Pilot Project area to be divided into smaller zones. The locations of the valves will determine whether the selected Pilot Project area is a suitable selection for obtaining measurements. It will also identify whether Leakage Monitoring Block (LMB) can be established in order to measure results. All valve locations in Majengo area in Narok were confirmed as shown in Figure 2.4 and mapped on diagram. Valves that were not functioning were replaced and new valves were installed in locations that were necessary.

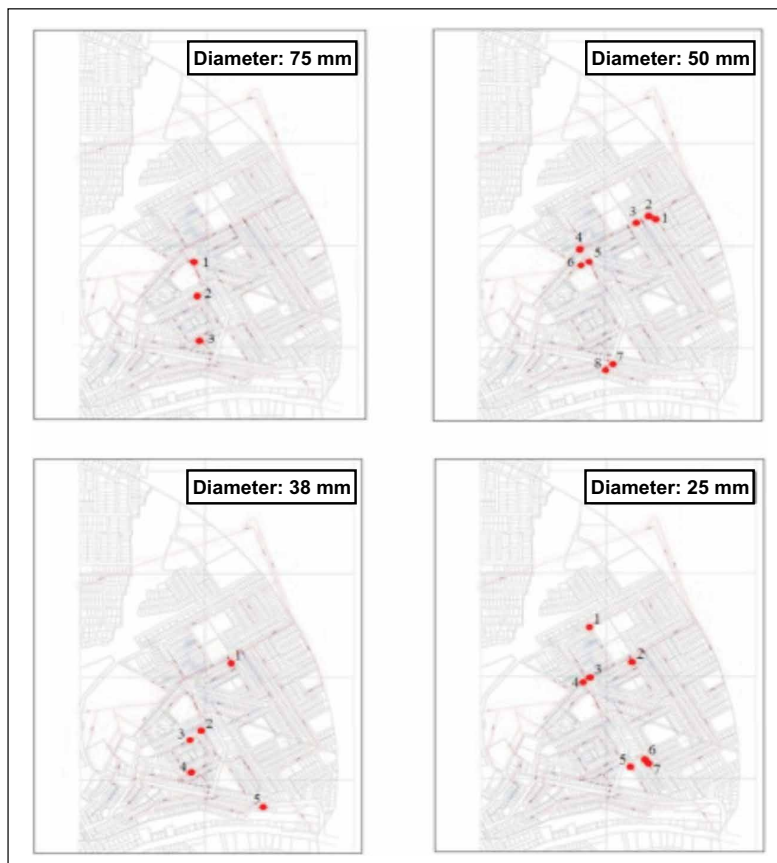
Figure 2.5 Location of Replaced and Newly Installed Gate Valve

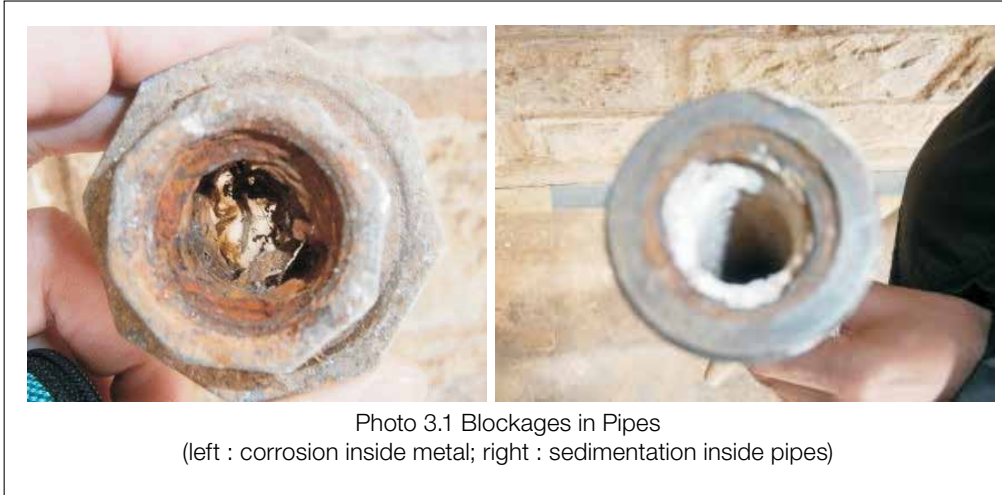
As shown in Photo 3.1, blockages were seen in distribution pipes in Majengo area (zone) due to corrosion and/or sedimentation. As a measure to this problem, pipes were replaced experimentally in eight (8) locations shown in Figure 3.5. Results showed that there were improvements in water flow inconsistencies.

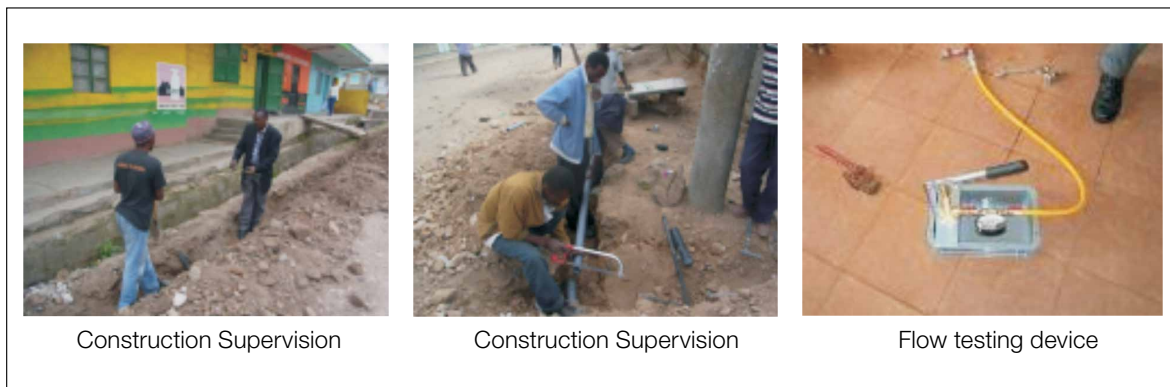
Photo 3.2 Construction supervision and flow testing device

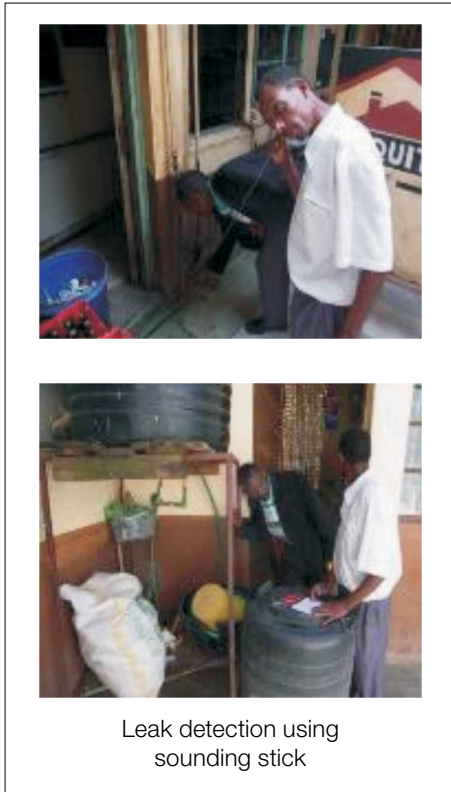
Photo 3.3 Leak detection activity

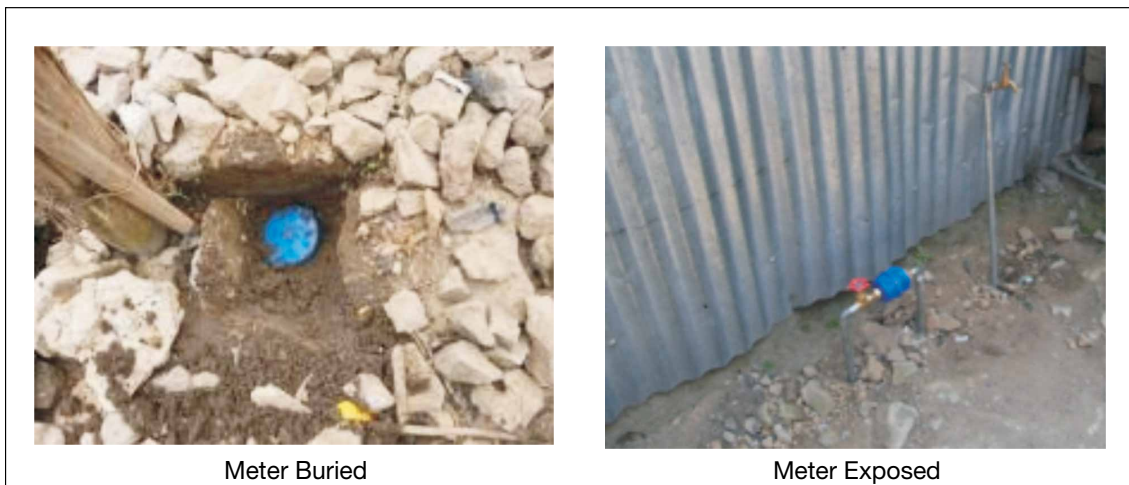
Photo 4.1 Buried and exposed customer meter
